## A590 Drainage Repairs, A590 Nr. Barrow

Client: EM Highway Services	Value: £750,000
Location: A590, Nr. Barrow in Furness	Duration: 16 Weeks

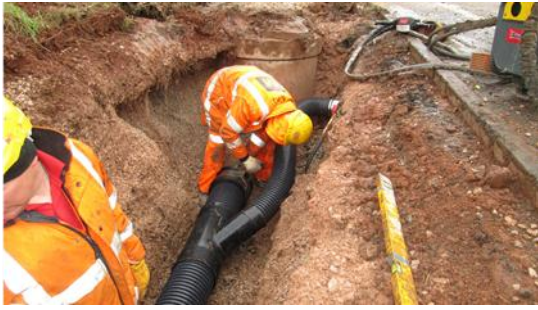
The repairs were to carrier and filter drains, in small sections as well as long runs between manholes.

The repairs were done to varying lengths of drains, based on the surveys done by the client, and the schedule they had produced. The sections were either taken out and each end connected with a band seal, or done in full runs between two manholes. Any extra repairs that were discovered were fixed at the same time. Some sections of drain were repaired by slip-lining where they crossed under the carriageway (by a subcontractor). The drains were CCTV surveyed at the end to ensure they were clear.

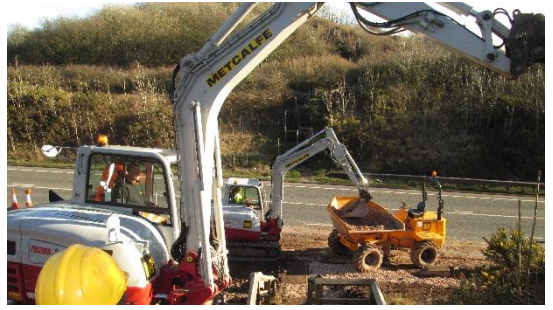
Drains at the top of batters, in surrounding fields and other small drains were repaired where necessary.

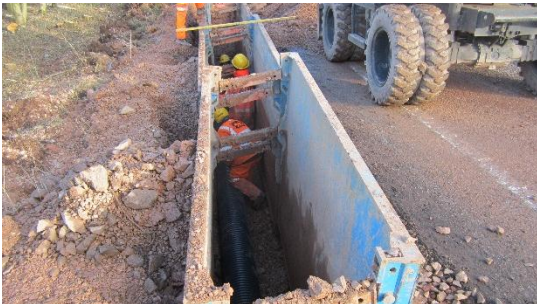
Working in made-up ground meant trench support was needed for a lot of the excavations.

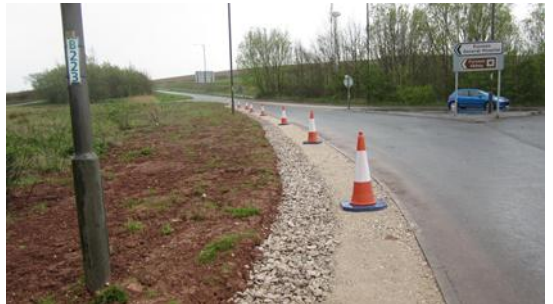
A finished section of filter drain. Sub-base was used to trim the edge next to the carriageway.

The filter drain stone was renewed at the same time. The existing dirty stone was excavated and taken to be washed and recycled. New stone was then imported to top up the drains.

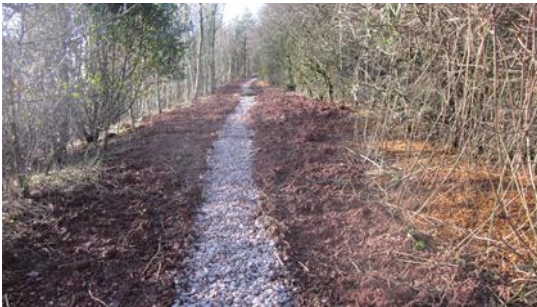
Another finished filter drain. This was one of a number of field and top batter drains repaired or replaced

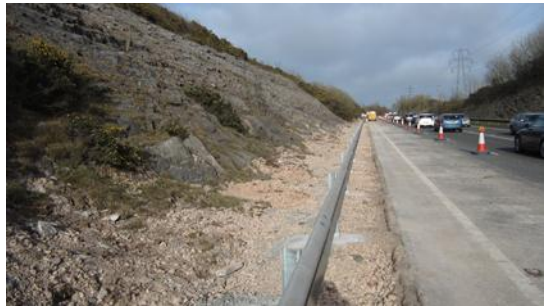
A section of crash barrier that has been replaced.

Subcontractors were employed to repair and replace sections of crash barrier as part of the contract.
