Riverbank Restoration, Ennerdale Bridge

Project information

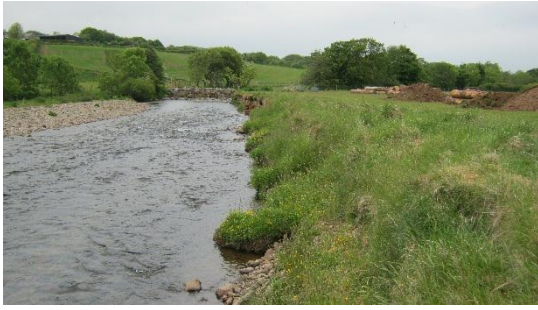
The existing riverbank was eroding during floods, destroying the land on the outside of the bend.

The aim of this project was to re-profile a riverbank, so as to prevent further erosion of a field which had been damaged by flooding. The works were done for West Cumbria Rivers Trust in the River Ehen.

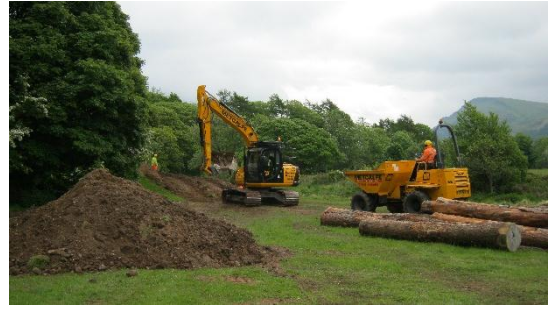
Rock armour (rip rap) stone and logs were delivered to site and taken down in dumpers.

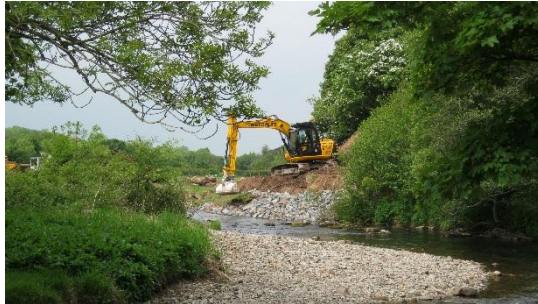
The rock armour was placed at the toe of the higher banking.

The first section was stabilised using “rip-rap” rock armour stone at the toe of the embankment. Care was taken to find stone from a non-limestone source, so the river wouldn't become contaminated.

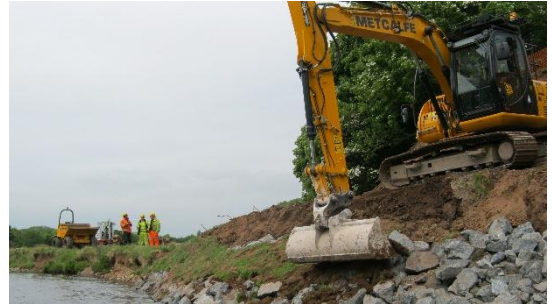
Topsoil was used above the rock armour and the logs to re-profile the embankment.

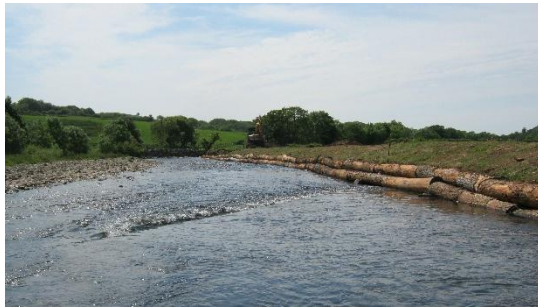
The logs were pre-drilled and lifted into place, then secured with steel pins.

The logs were sourced from a local supplier, and delivered to site on timber wagons. They were pre-drilled, and taken to the riverside. Once in place the logs were pinned with rebar and the joints were tied using the pig-netting normally used for fencing. The whole embankment was re-profiled with topsoil.

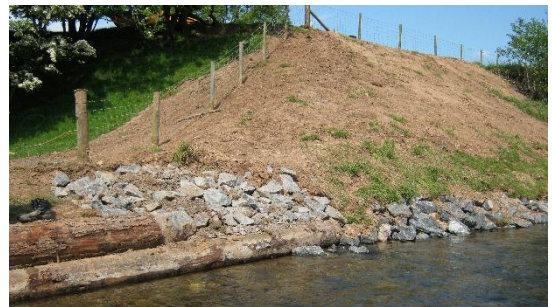
The logs were used on the shallow section and blended into the rock armour section.
