Seascale, Sea Wall Repairs

Project information

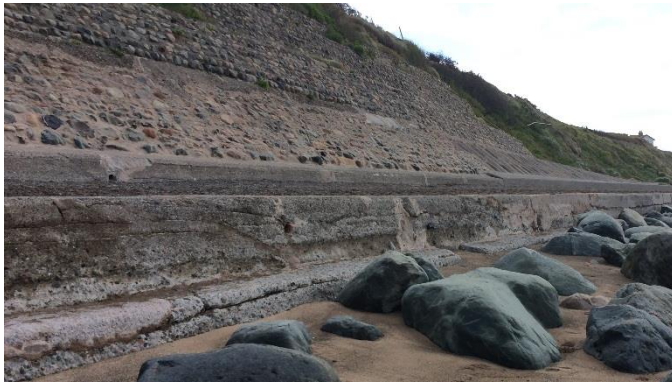
The existing sea wall was beginning to show signs of wear, and required a new concrete face.

The aim of this project was to extend the existing sea wall. The wall had various defects including cracks and spalling of the concrete.

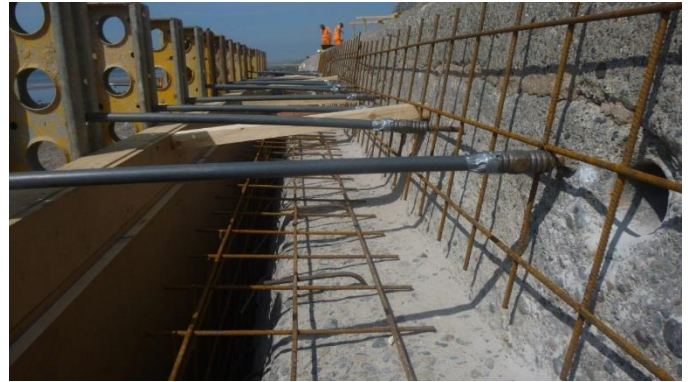
The first lift of concrete was fastened to the foundation and the existing wall. Steel mesh and L-bars ensured a permanent hold.

The new concrete face was required to be tied into the old. This meant inserting L-bars into the old concrete, and extending the drainage weepholes through.

When the base of the wall was excavated, it was discovered there was no 'toe' to the wall. This meant a new foundation needed to be poured. This was a compensation event which was agreed with the client. This was dealt with swiftly by both parties and had a minimal impact on the programme.

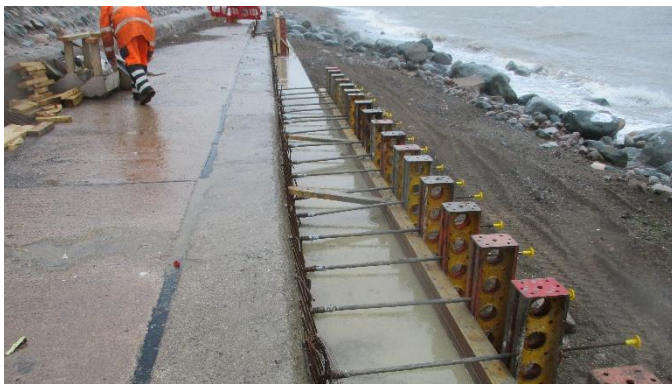
The top lift was attached to the bottom and the existing wall.

The wall had a step, so it had to be cast in two lifts. The lower shutters were fastened to the toe of the wall, and braced through the shutter to stop them moving when the concrete was poured. The top shutters were fastened to the new concrete, and braced along the top.

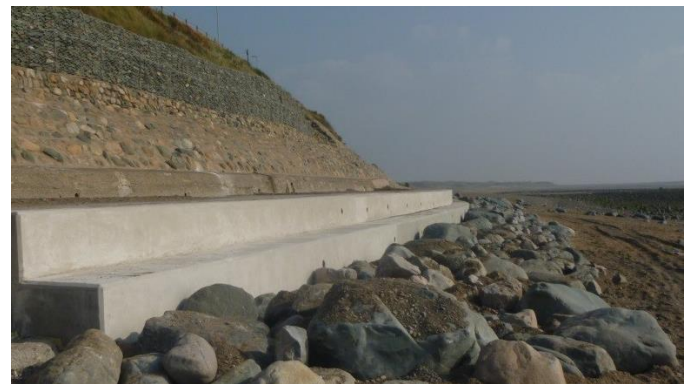
The finished length of wall with the rock armour in place.

The finished wall was rubbed up to remove any final imperfections, and then the boulders which were spread across the beach were gathered up and placed as rock armour as extra protection.
