Landslip and embankment restoration at Buttermere to Scarth Gap

Description of the works

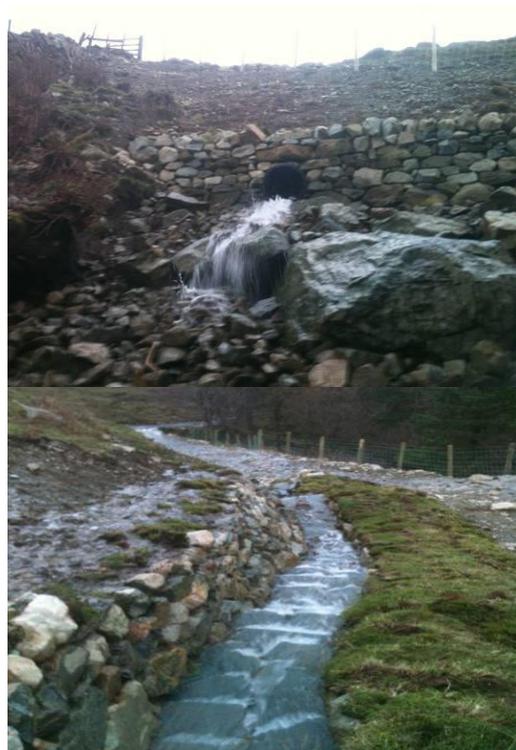
The gabions were constructed on site and fair stone faced to present an aesthetically pleasing finish to tie in with the location. Two pipes were installed, one to catch water coming down the footpath, and one to catch water seepage flowing under the structure. These pipes were backfilled with stone which allowed water to flow through the structure without washing it away. The structure was finally covered with topsoil and blended into the landscape. Additional work was instructed by the LDNPA to provide slate cut off drains are shown in the adjacent photo.
